# GEOTEXTILES AND MICROPLASTICS

Document type  
**Report**

Date  
**November 2022**

## GEOTEXTILES AND MICROPLASTICS IN SWEDEN **AN ASSESSMENT**

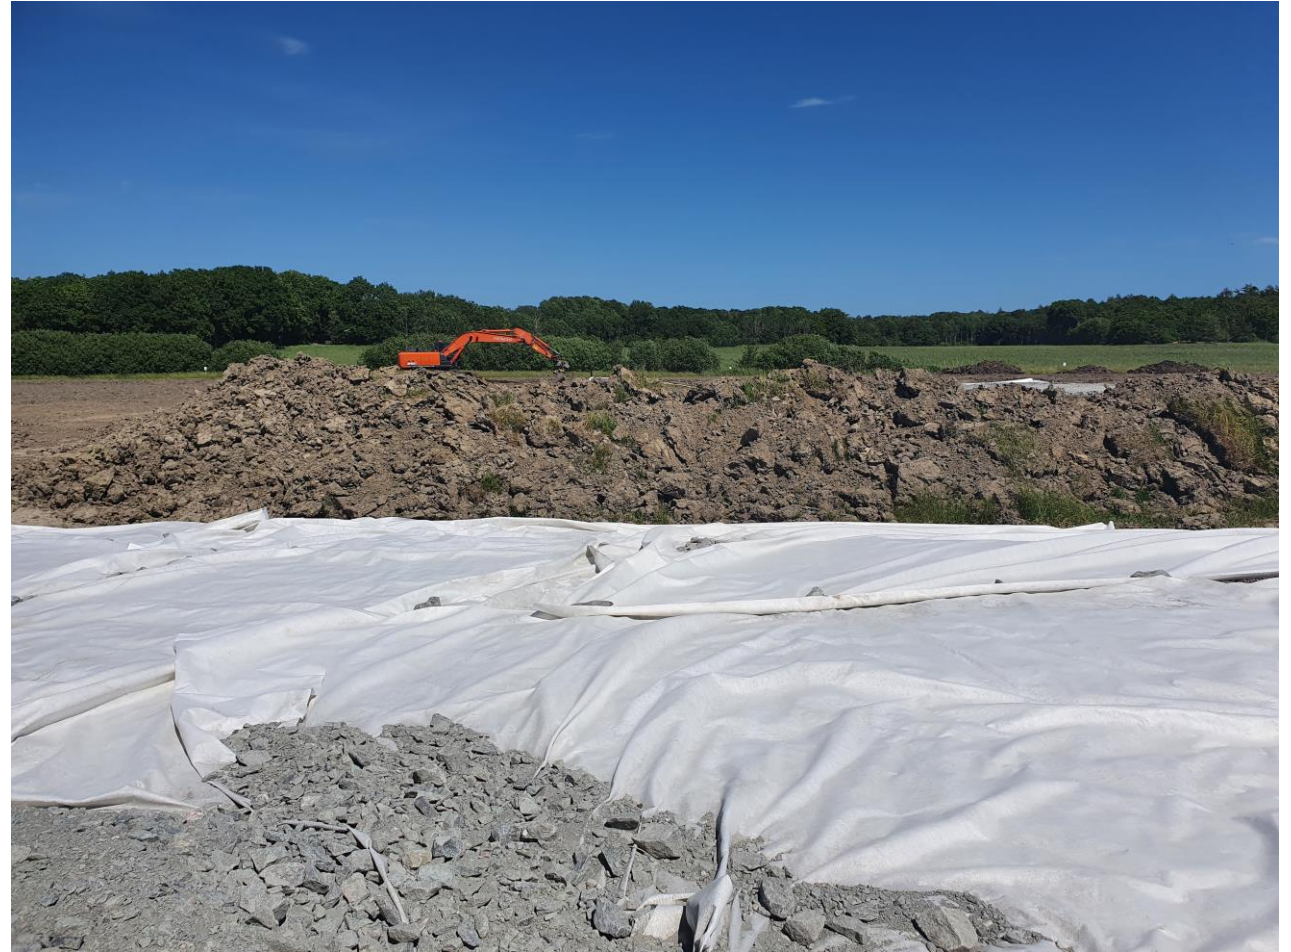
Photo: VästMark Entreprenad AB

- Degradation factors synergistic and weaken the geotextile.
- UV-exposure most important but also abrasion, chemical degradation, hydrolysis, biological degradation
- Not covering geotextiles according to instructions and hydraulic applications identified as risk uses.
- Relationship between degradation factors and microplastic formation not clear
- Fragments of geotextile have been identified on beaches in the Baltic Sea
